Internal Moisture & Mold Applications

Flat Roof Moisture Survey

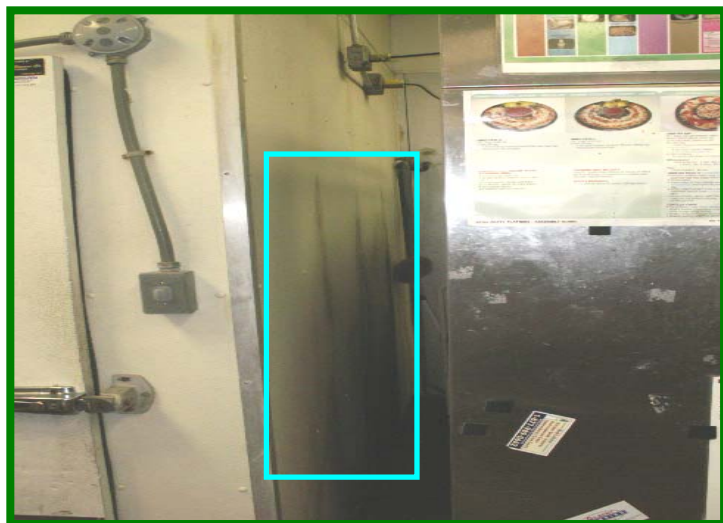
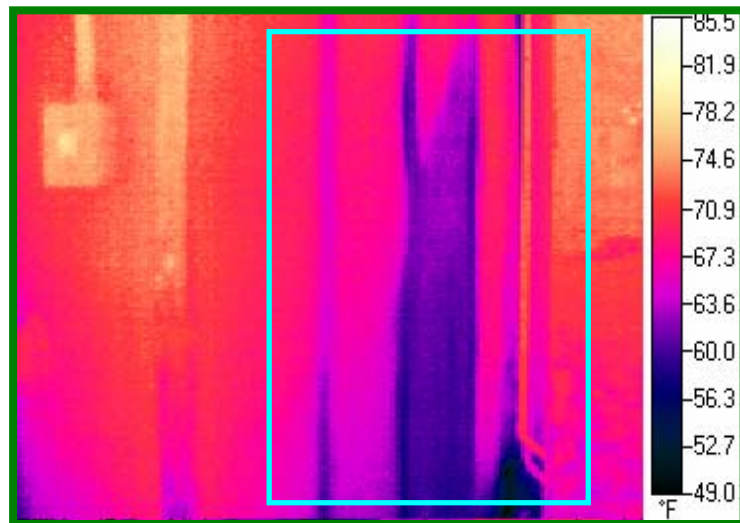
Internal Moisture and Mold Indicated behind exterior refrigeration panel due to excessive condensation and internal moisture.

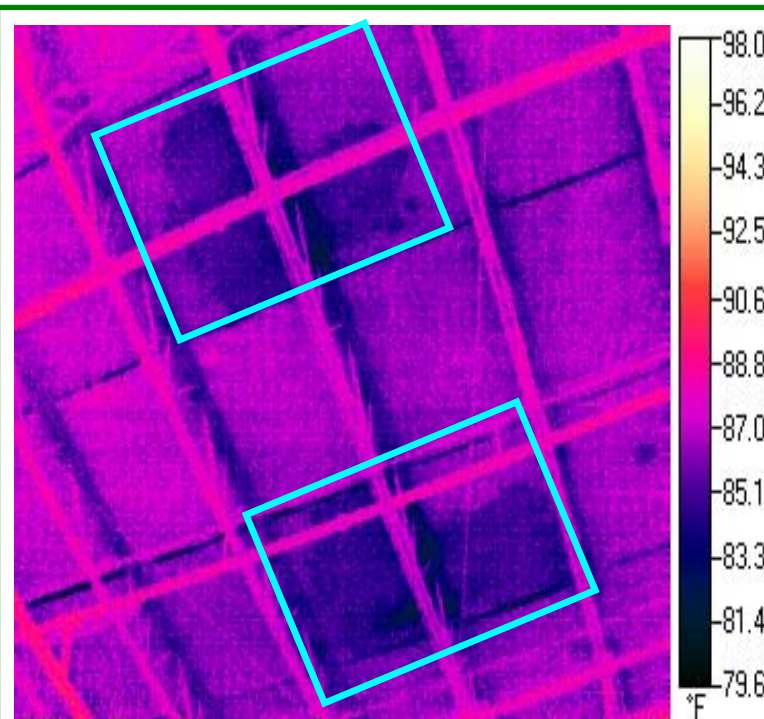
Internal Thermal Image

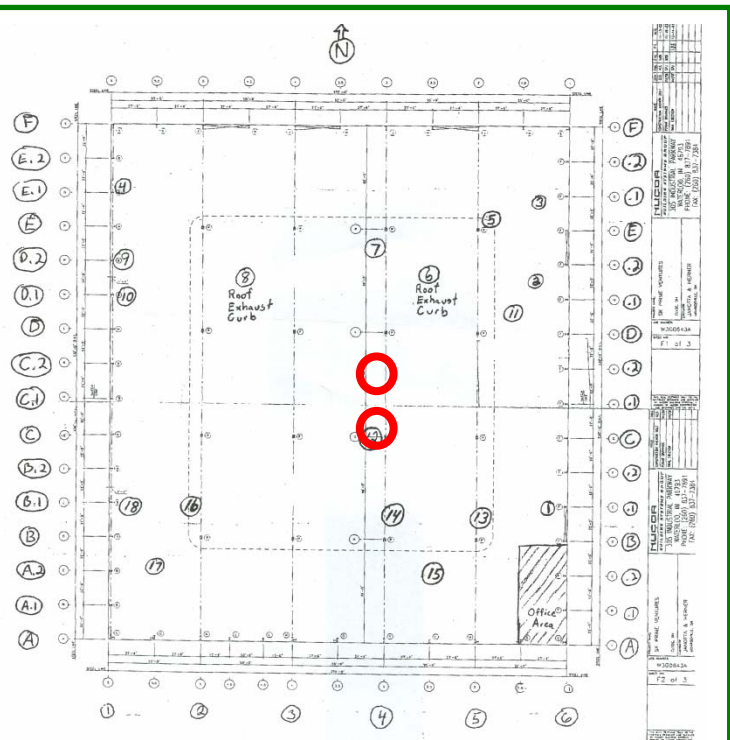
Internal Moisture located under a Metal Pitched Roof
Internal Moisture will deteriorate the internal building structure, create mold, and destroy the internal insulation.

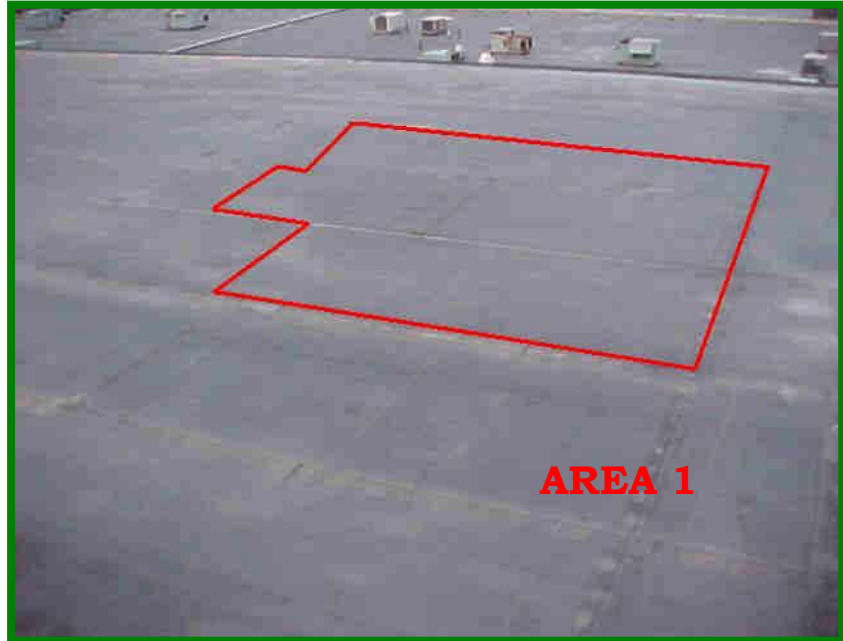
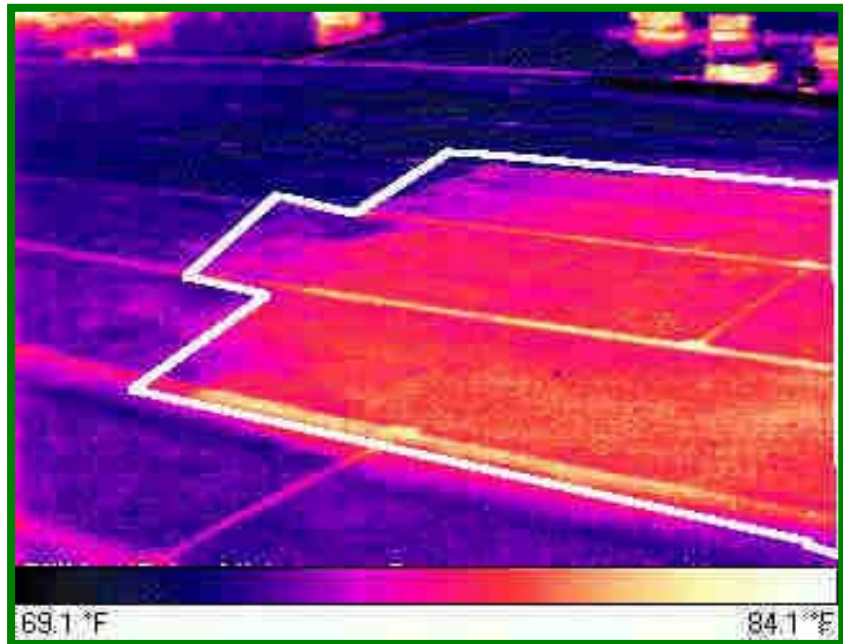
INVENTORY No. 028

FINDINGS: Built-Up Construction

A continuous semi-flexible roof coverings of laminates, or piles, of saturated or coated felts alternated with layers of bitumen. Surfaced with asphalted materials.

RECOMMENDATIONS: Consult with an experienced roofing contractor to confirm results. (Core samples are suggested to confirm thermal analysis).

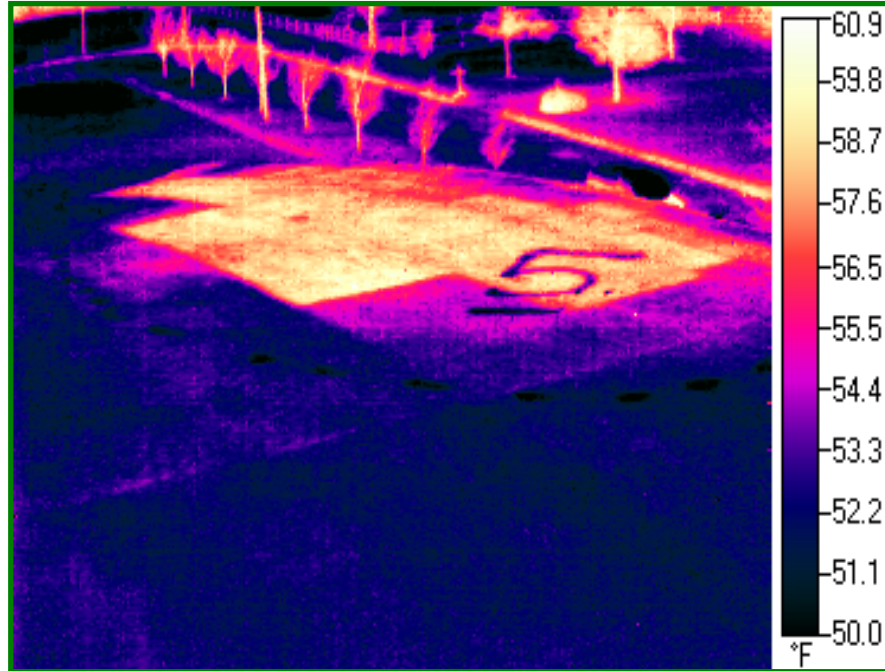
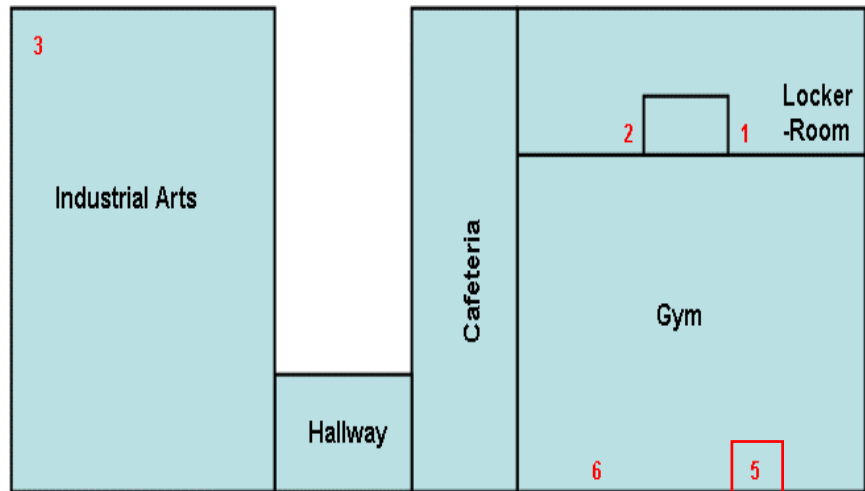
Area 5

Survey Findings: Suspect internal moisture saturation.

Notes: All moisture should be removed to eliminate internal damage to the deck and other internal structures

Survey Recommendations: Based on all related information an internal core sample should be taken to confirm findings.
